VEHICLE IMPACTS ON VEGETATION COVER AT CAMP ATTERBURY, INDIANA: PART 1. INITIAL IMPACTS AND VEGETATION RECOVERY

ABSTRACT. Geographic Positioning System (GPS) based vehicle tracking systems were installed on three military vehicle types (M88 tank recovery vehicle, M35A3 cargo truck, and M1009 utility cargo vehicle) at Camp Atterbury, Indiana, to assess the impact of vehicle traffic on vegetation. Vehicle tracking systems recorded the position of each vehicle every second. Instrumented vehicles were driven through courses of varying velocities and turning radii. GPS position data were used to calculate vehicle velocities and turning radii throughout the course. Vegetation damage along vehicle tracks was recorded immediately, 5 months (end of the first growing season) and 12 months after tracking. Vegetation damage was quantified by both the amount of vegetation lost and the area impacted. Vehicle type, turning radius (*TR*), velocity (*V*), and *TR*·*V* interaction were found to significantly affect all vegetation damage measures. The tracked M88 tank recovery vehicle caused more vegetation loss than either of the wheeled vehicles (M35A3 cargo truck and M1009 utility cargo vehicle).

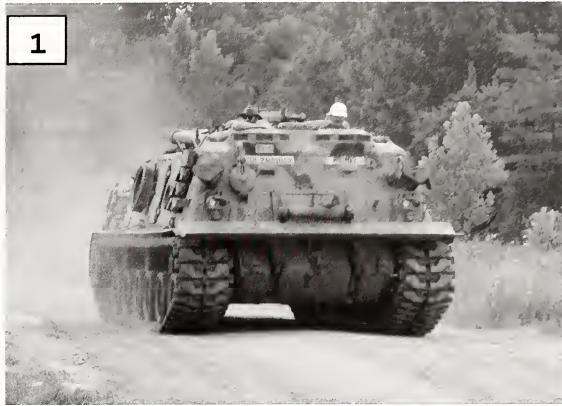
Figure 1–3.—Three vehicle types used in tracking study include the M88 tank recovery vehicle (Fig. 1), the M35A3 cargo truck (Fig. 2), and the M1009 utility cargo vehicle (Fig. 3).

Study design.—A field study was conducted on 24 July 2001 using three vehicles: M88 tank recovery vehicle, M35A3 cargo truck, and M1009 utility cargo vehicle (Figs. 1–3). The M88 tank recovery vehicle is a tracked vehicle that is 8.52 m long, 3.40 m wide, 3.10 m high with a weight of 50.8 t. The M88 track width is 71.1 cm with pads that are 26.7 cm wide by 16.5 cm long. The M35A3 cargo truck is a six-wheeled vehicle with a 4.50 m total wheelbase, 2.40 m outside to outside width, and weight of 3.5 t. The M35A3 tire height is 107.0 cm with a tread width of 23.5 cm. Tire pressure was 345 kPa during the study. The M1009 utility cargo vehicle (similar to a Chevrolet CD-10506) is a four-wheeled vehicle with a 2.70 m wheelbase, 1.40 m width, and a weight of 2.4 t. The M1009 tire height is 78.7 cm with a tread width of 26.7 cm. Tire pressure was 345 kPa during the study.

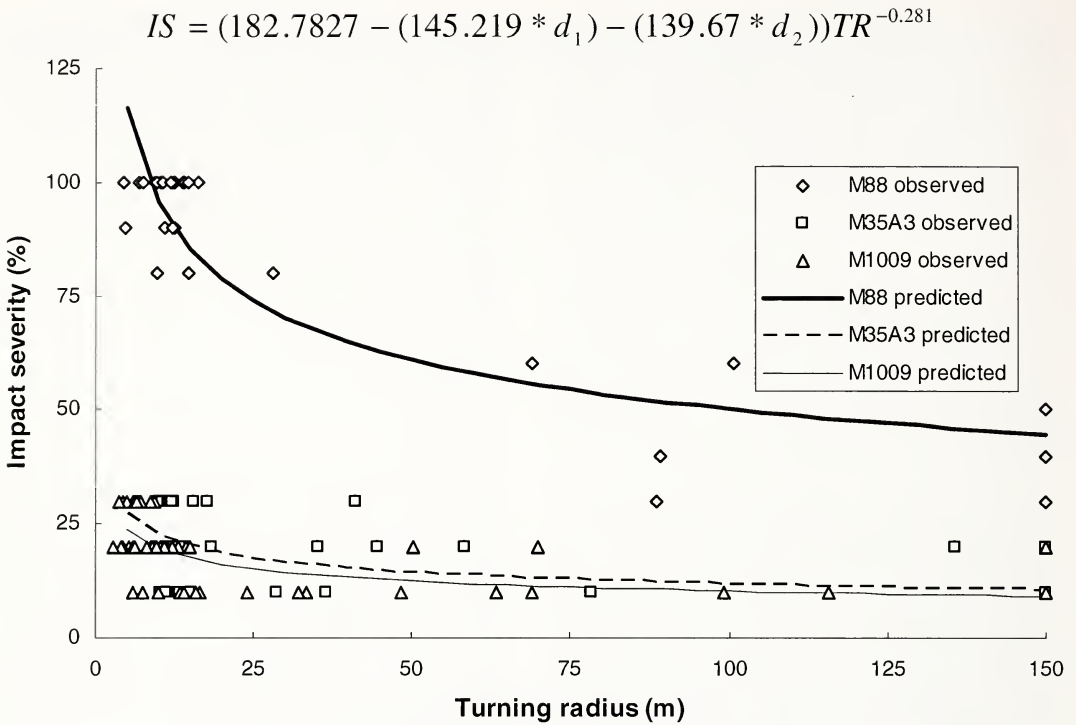
Figure 4.—Impact Severity (IS) as a function of turning radius (TR) for the M88 tank recovery vehicle, M35A3 cargo truck and M1009 utility cargo vehicle. Parameterized power equation for fitted lines provided at the top of the graph. Variables d_1 and d_2 are dummy variables that account for vehicle type. The dummy variables d_1 and d_2 have the value of $d_1 = d_2 = 0$ for the M88, $d_1 = 0$ and $d_2 = 1$ for the M35A3, and $d_1 = 1$ and $d_2 = 0$ for the M1009. R^2 fit for the equation is 0.924.

Impact severity, disturbed width, and cumulative impact increased exponentially with decreasing turning radii (Figs. 4–6). The M88

Impact measures increased suddenly at turning radii less than approximately 15–20 m for all vehicle types. Despite drastically different static vehicle design characteristics, the critical turning radii for site damage were very similar among vehicles.

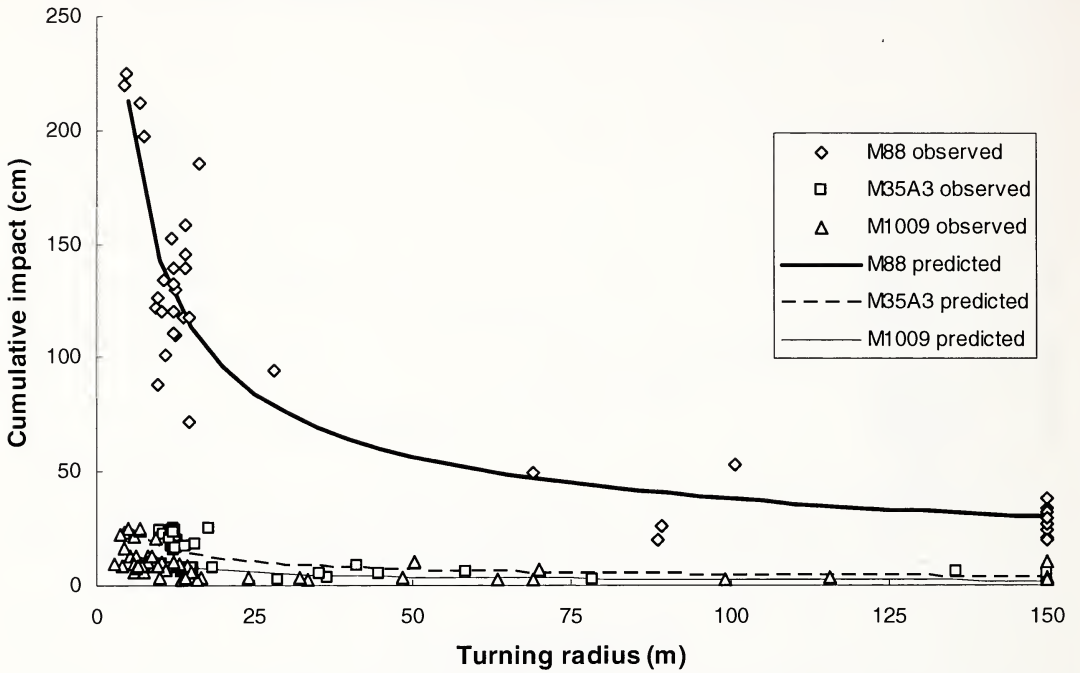
Figure 6.—Cumulative impact (CI) as a function of turning radius (TR) for the M88 tank recovery vehicle, M35A3 cargo truck and M1009 utility cargo vehicle. Cumulative impact was calculated as the product of the impact width and impact severity. Parameterized power equation for fitted lines provided at the top of the graph. Variables d_1 and d_2 are dummy variables that account for vehicle type. The dummy variables d_1 and d_2 have the value of $d_1 = d_2 = 0$ for the M88, $d_1 = 0$ and $d_2 = 1$ for the M35A3, and $d_1 = 1$ and $d_2 = 0$ for the M1009. R^2 fit for the equation is 0.924.

$$CI = (538.2323 - (501.464 * d_1) - (473.774 * d_2))TR^{-0.5764}$$

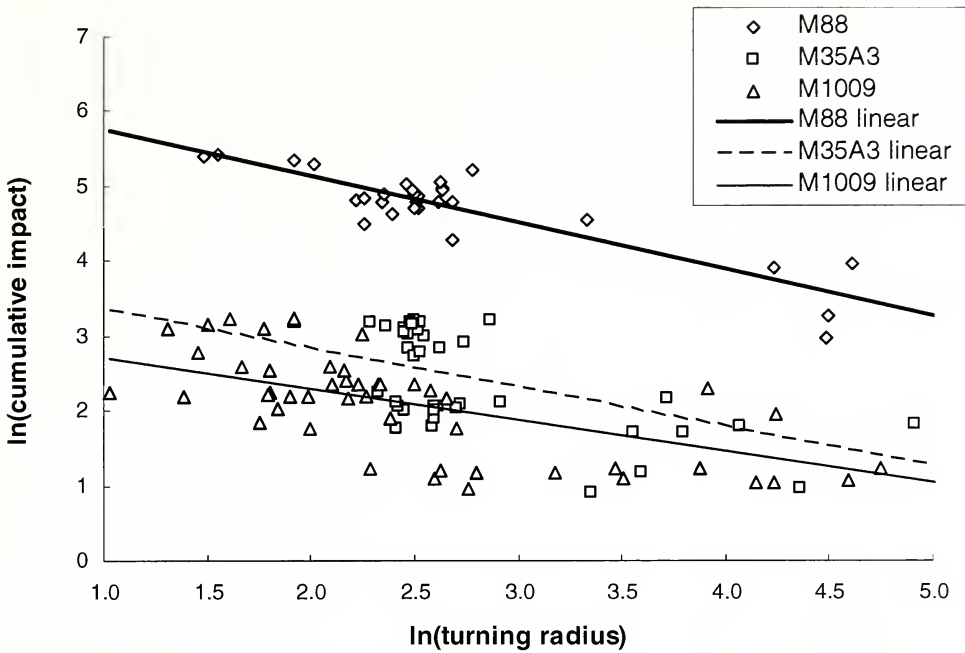
Figure 7.—Relationship between logarithmic transformation of both cumulative impact and turning radius data by vehicle type. Lines show best fit for linear relationship between variables. R^2 fit for M88 tank recovery vehicle, M35A3 cargo truck and M1009 utility cargo vehicle are 0.90, 0.40, and 0.49, respectively.

amic properties (turning radius and velocity) resulted in linear relationships between dependent and independent variables. Figure 7 shows a typical relationship between transformed impact measure and vehicle dynamic property.

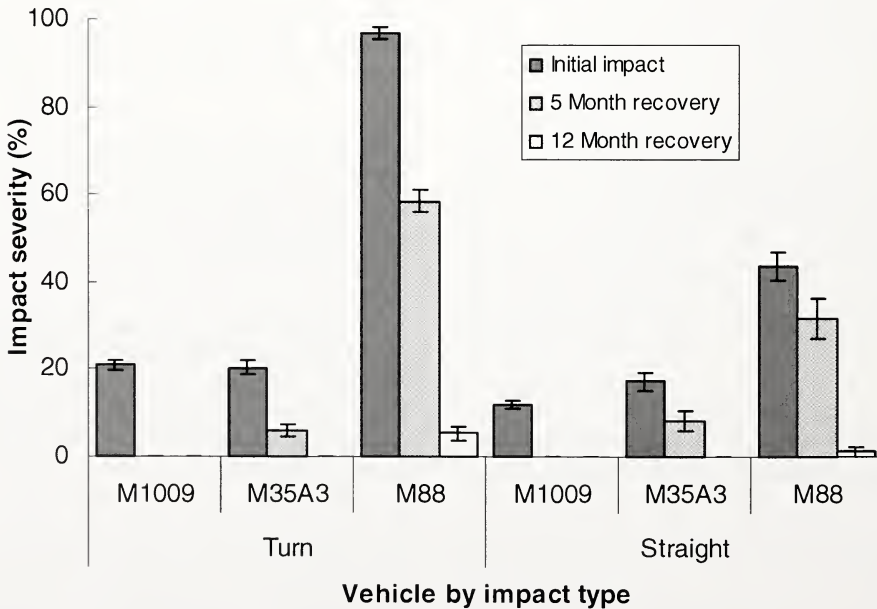
Figure 8.—Impact severity by vehicle type (M88 tank recovery vehicle, M35A3 cargo truck and M1009 utility cargo vehicle) for straight-line and turn tracking immediately, 5 months and 12 months following tracking. Straight-line tracking includes all data for turning radii greater than or equal to 20 m. Turn tracking includes all data for turning radii less than 20 m. Error bars represent \pm one standard error. Impact severity at 5 and 12 months for M1009 is zero for both turn and straight tracking. Impact severity at 12 months for M35A3 is zero for both turn and straight tracking by 12 months.

less than 5 months to about 12 months for all vehicle and impact types (Fig. 8). Recovery times for the M1009 utility cargo vehicle were shorter than the M35A3 cargo truck, which were shorter than the M88 tank recovery vehicle. Recovery times were similar for straight-line tracks and curves despite differences in initial impacts.
